Protecting Wooden Doors, Windows, and Wall Framing from Decay

Terry L. Amburgey and Michael G. Sanders

SCH Report 11

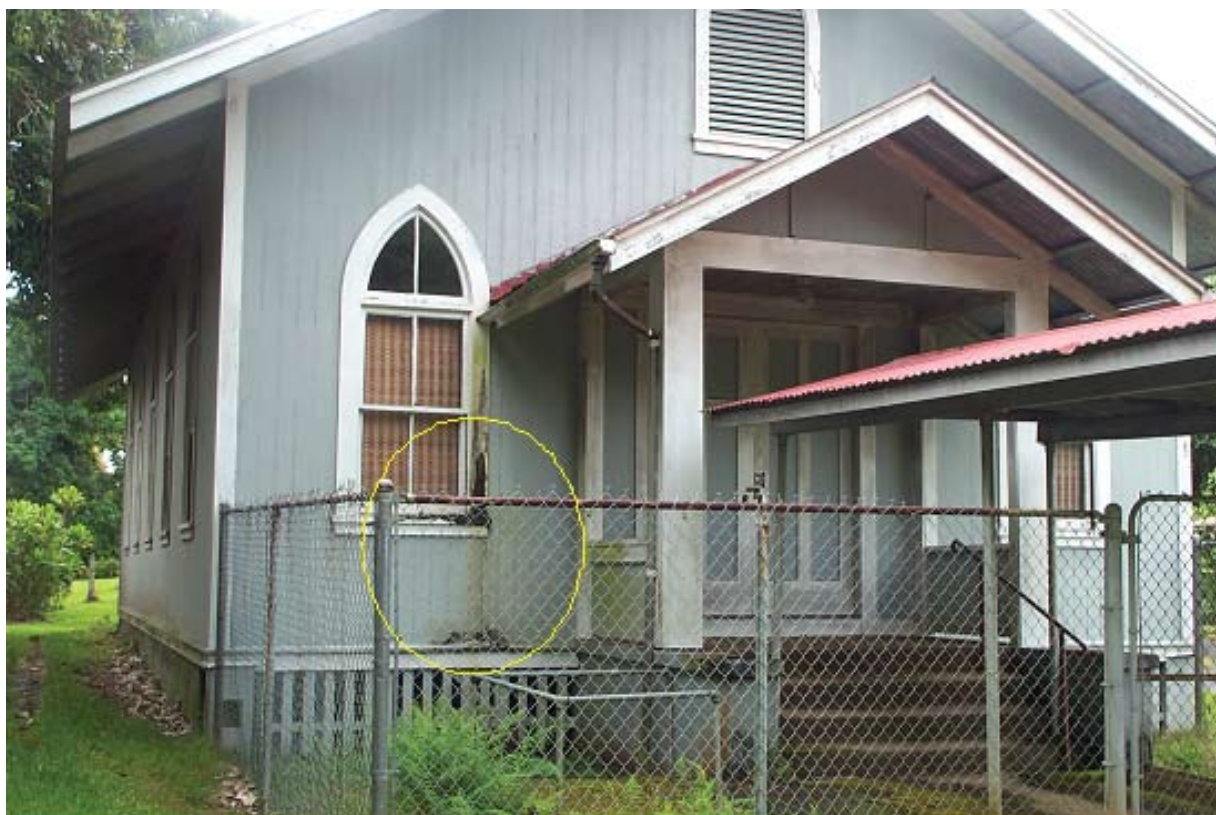
Figure 1 – Wind-driven rain and/or building design features that direct moisture to windows are some of the many ways moisture penetrates wall openings.

Openings in the building envelope for windows, doors, etc. frequently are areas where water penetrates the wall voids and results in decay of framing and other building components. Condensation on the windows, building features that direct rainfall toward windows or doors (Figure 1), and/or wind-driven rain/moisture are the principal ways moisture enters these areas. Window manufacturers utilize dip, spray, or vacuum preservative treatments and have developed alternative installation procedures to protect the wooden components of their products from decay and to decrease the ingress of moisture past the envelope. However, wetting and decay of building materials such as framing and window components persist.

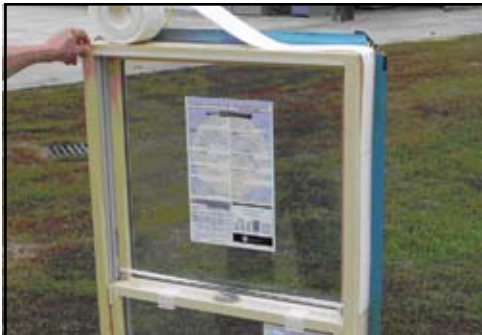
Figure 2 – A non-biodegradable material treated with a diffusible preservative can be applied to pre-hung windows at the factory, building site prior to installation, or in place on existing windows.

- Treatment #1 - Stapling a 3-inch wide strip of non-biodegradable absorbent material that had been previously treated to refusal with a 10% aqueous solution of Timbor , a water diffusable borate product, and allowed to dry before the material was fastened to the pre-hung windows (Figure 2) or doors (Figure 3).

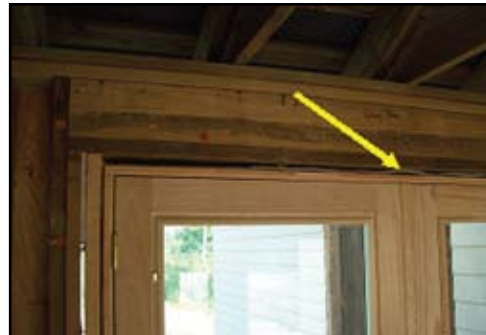
Figure 3 - A non-biodegradable material treated with a water - diffusible preservative can be applied to pre-hung doors at the factory, at the building site prior to installation, or while in place.

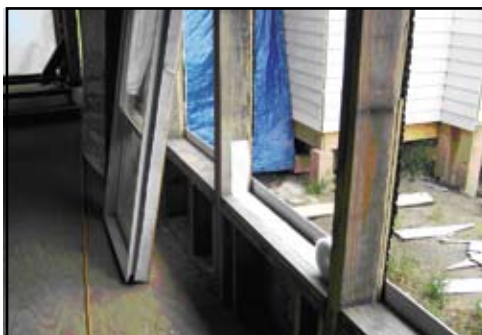
Figure 4 – A borate-treated fibrous strip being fastened to the house framing prior to installation of windows.

- Treatment #2 - In addition to the procedure used in treatment #1, the framing surrounding window openings, and the framing and sheathing from below the windows to the floor, were treated with a commercially available water-repellent preservative (WRP) formulation.
- Treatment #3 -Rather than the procedure described in Treatment #1, the borate-treated fibrous strips were stapled to the wall framing surrounding the window opening (Figure 4).
- Treatment #4 - No treated fibrous strip of material was applied to either the window or adjacent wall framing. A WRP was applied as discussed in Treatment #2 (Figure 5).

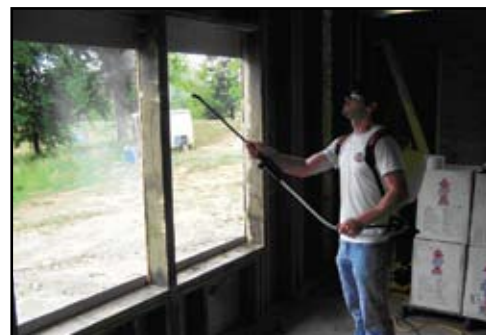
Figure 5 – Framing adjacent to a window opening, and framing/sheath below the opening being sprayed with a water-repellent preservative prior to installation of a window.
