# Acoustic emission detection of upholstered furniture frame damage

Jilei Zhang\*  
Franklin Quin  
Li Dai\*

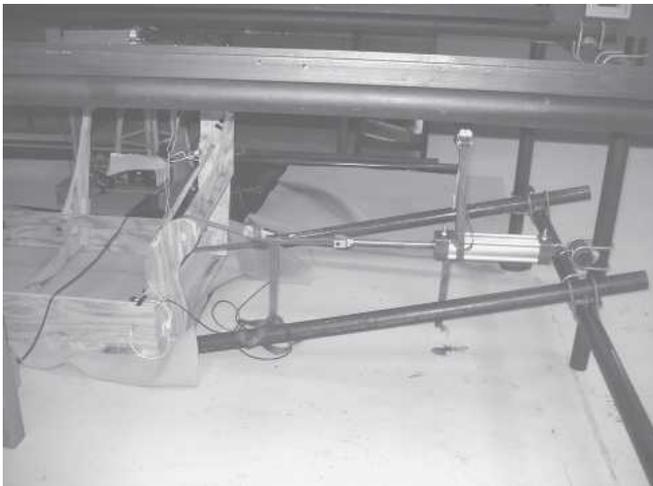
Figure 2. — Set-up for the horizontal sidethrust load test on arms for sofas.

Two stationary three-seat bare sofa frames were supplied by a local manufacturer for acoustic evaluation as shown in **Figure 1**. The frames were mainly constructed with pine plywood. Particleboard was used only for bottom side rails. One of the frames was constructed with both staples and glue and the other frame was constructed with staples only. The glue was a polyvinyl acetate emulsion adhesive with 52 percent solids content. Typical joints were mortise and tenon type, for instance, upright to stretcher (in-plane) and top arm rails to back posts (out of plane), and also end to face type with reinforced corner block, for instance, upright to top rail as shown in **Figure 1**. Each frame was subjected to two GSA frame performance tests, the backrest frame test and the horizontal sidethrust load on arm test outward. **Table 1** shows the testing load schedule for the frames. According to the GSA testing standards FNAE-80-214 A the load is applied to the frames at a frequency of 20 Hz. **Figures 2** and **3** show the air cylinder and pipe rack setups for the horizontal sidethrust load test on

A horizontal force in an outward direction was applied using an air cylinder to the top arm rail end near to the intersection of the stump with the arm. Three microphones were placed at different locations to detect squeaking noise signals.

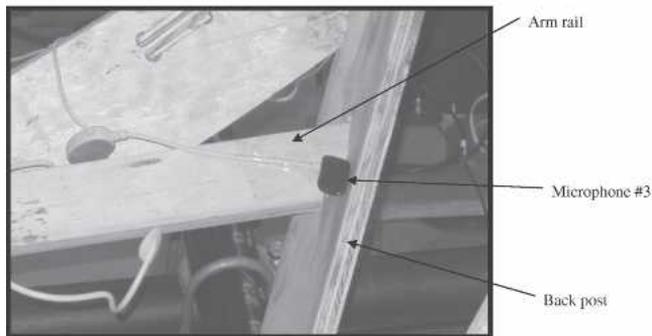
Figure 4. — Locations of microphones #1, #2, and #3 for the horizontal sidethrust load test on arms.

Microphones 1 and 2 (Fig. 4) were located right above the intersection of the stump to the bottom side rail and the intersection of the front rail to side rail. Microphone 3 (Fig. 4) was located at the rear of the arm at the top arm rail to back post intersection. Both of the arms were tested on each frame, the right side arm and the left side arm. The placements of the microphones were determined by observing the movement of the frame at these particular joints during the initial testing stage. A sheet of foam was placed underneath the frame in order to minimize any rubbing noise between the frame and the floor. The solenoids that control airflow to the cylinders were located away from the testing frames to reduce noise.

The results of the horizontal sidethrust load on arm test outward are summarized in **Table 3** for microphone #1 (Fig. 4) in terms of cycles and the average and range values of the amplitude of the first squeak region detected. No squeaking data were detected from microphones #2 and #3 located at the arm rail to back post intersection.
